Subject: Halkey Roberts V96000 Manual Inflator Service Bulletin

This service bulletin was developed to address intermittent issues with the indicator status of the 3F Single Point Manual Inflator.

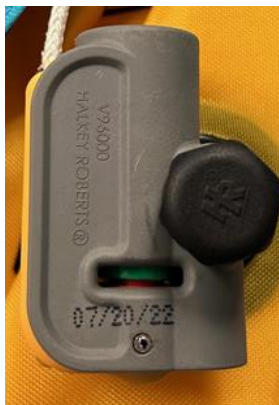
Figure #1

It has been reported that on occasion when removing a full CO₂ cylinder from an unfired manual 3F inflator, the indicator status can remain green or partially green/red (Figure #1). The inflator can be reset with a simple set of instructions to ensure proper indication.

1. Open up the vest so that the inflator unit and cylinder are visible and can be serviced.
2. Remove the CO₂ cylinder from the operating head.
3. Inspect the indication system for status.
4. Rotate the yellow lever to a fired / actuated position (Figure #2) and then return the lever to its “ready” position. (Figure #3)
5. Reinstall the full CO₂ cylinder and confirm a “green” ready status indicator. (Figure #4)
